A MOSBY SUCCESS STORY

CREATING A PROVEN SOLUTION THAT HOLDS WATER

CHALLENGE: A HOME SHOWS SIGNS OF WATER DAMAGE, WITH NO APPARENT CAUSE.

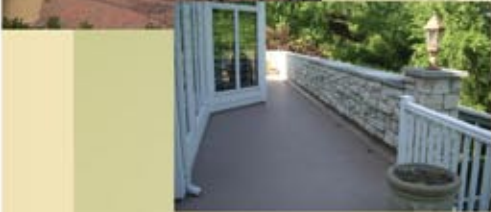
Signs of water damage appeared on the deck and pool house.

On the deck, the rubber flooring showed signs of water problems.

Noticeable cracking in the stone suggested water penetration.

The peeling finish on the drywall suggested water damage which was confirmed as shown below.

A proper water management system was installed and a new deck was built without disturbing the pool room below.
