A MOSBY SUCCESS STORY

SOLVING A MYSTERY – AND SAVING A HOME

A PUZZLING WATER LEAK...CONTINUED

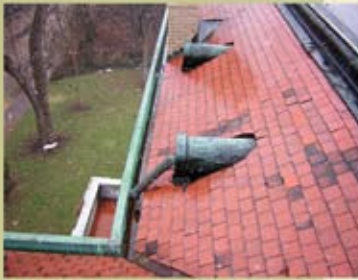
The interior wall leaks were coming from the clay tile roof.

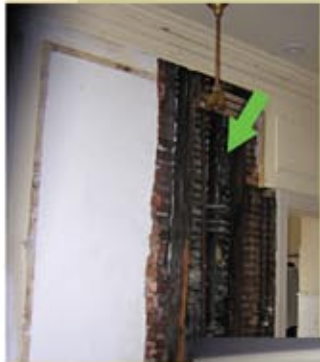
Walls were opened exposing the failed pipes of the internal gutter system.

Pipes from roof to basement were removed.

The clients' confidence grew as Mosby began repair work and replaced two sets of old, rusted cast-iron pipes running from the roof to the basement. The Mosby team also made structural repairs, installations, and cosmetic enhancements. There is no longer the sound, smell or damage of dripping water. The wall will remain dry for another century or more.

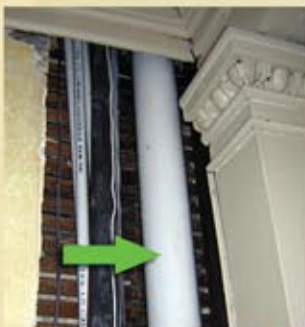
It was a delicate process to install the new pipe and to preserve and protect the historic character of the home.

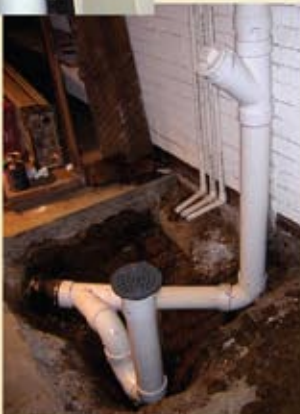
A whole new, modern system was installed.
